**Flood Control Project Maintenance
Levee Inspections**

Fall 2012 Levee Maintenance Deficiency Summary Report

Sacramento River Basin

Reclamation District No. 1660 Tisdale

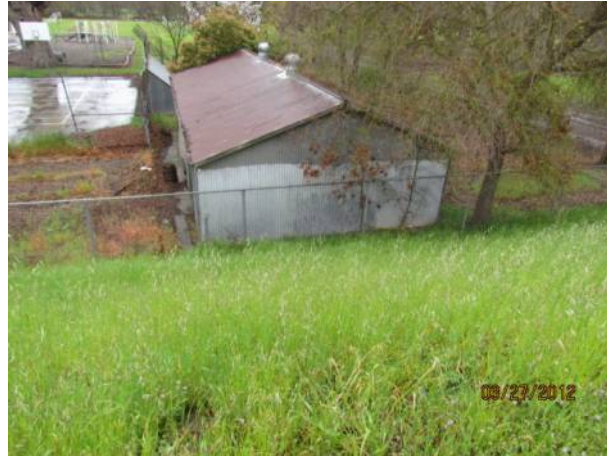
Levee Mile Report Line	4
Start Levee Mile	0.05
End Levee Mile	0.05
Location	Land Side
Category	Earthen Levee
Item	Encroachments

View of the building and fence at the landside toe.

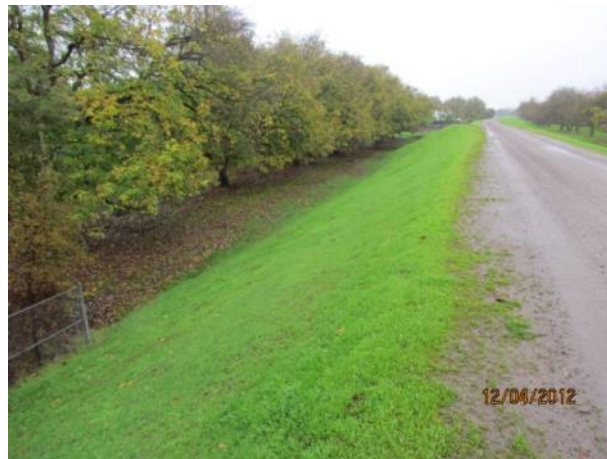
Levee Mile Report Line	5
Start Levee Mile	0.08
End Levee Mile	0.10
Location	Land Side
Category	Earthen Levee
Item	Animal Control

View of the repaired rodent holes along the landside slope of the levee.

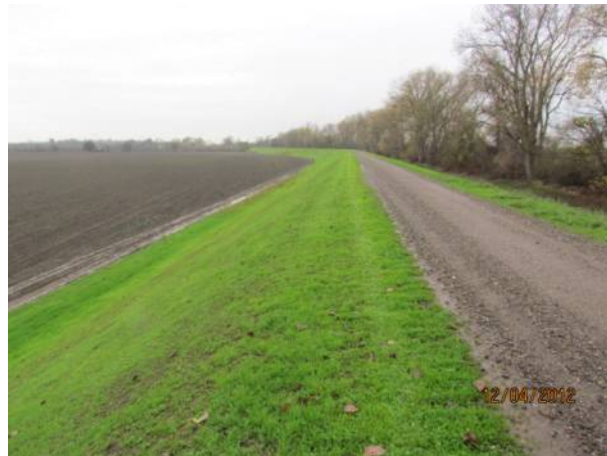
Levee Mile Report Line	6
Start Levee Mile	0.86
End Levee Mile	0.86
Location	Land Side
Category	Earthen Levee
Item	Vegetation

View of the vegetation starting to grow on both slopes of the levee.

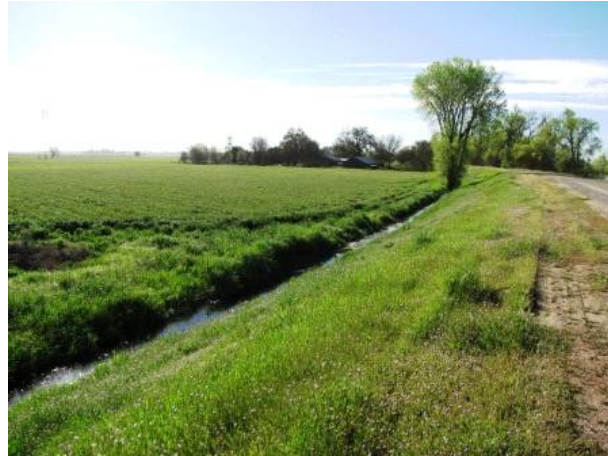
Levee Mile Report Line	7
Start Levee Mile	1.12
End Levee Mile	1.43
Location	Land Side
Category	Earthen Levee
Item	Encroachments

View of the ag ditch along the L/S toe.

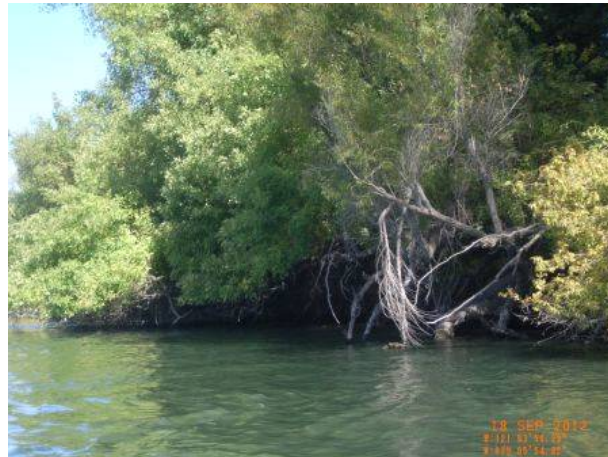
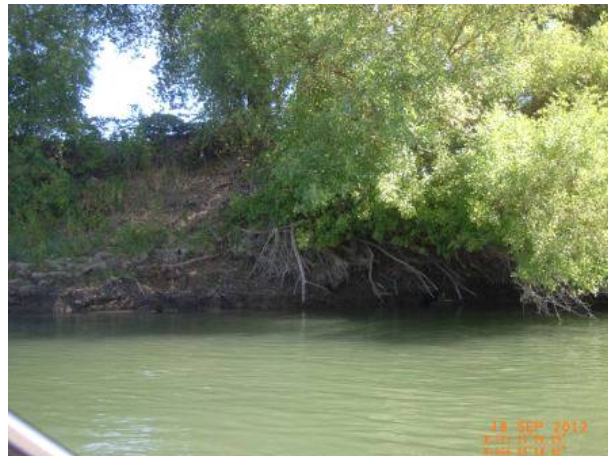
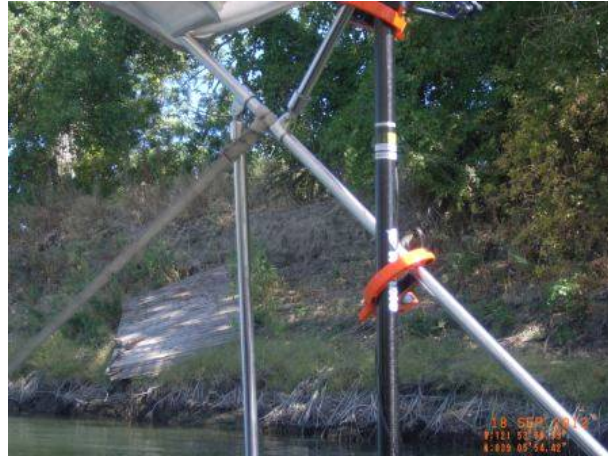
Levee Mile Report Line	8
Start Levee Mile	1.32
End Levee Mile	1.35
Location	Water Side
Category	Supplemental
Item	USACE Erosion Survey

DWR ID: DWR_RD1660_01_f_2012_16										
7	1.12	1.43	Earthen Levee	Encroachments	LS	M En	DT : Ditch	39.047610 ° -121.838802 °	39.043622 ° -121.836445 °	9 Y
DWR ID: DWR_RD1660_01_s_2012_9										
8	1.32	1.35	Supplemental	USACE Erosion Survey	WS	M Ma	Inspector Comments: 2009 - Erosion on levee toe where an old cobble site is failing. 2011 - Some new minor erosion. 2012: Site extended downstream, bank is negatively being impacted from the weight of the trees. [2012 Site ID: SAC_120-6_L]	39.044361 ° -121.837654 °	39.043916 ° -121.837305 °	11 Y
DWR ID:										
9	2.04	2.38	Earthen Levee	Encroachments	LS	M En	DT : Ditch	39.037640 ° -121.828421 °	39.034416 ° -121.825698 °	1 Y
DWR ID: DWR_RD1660_01_s_2012_1										
10	2.42	2.42	Earthen Levee	Slope Stability	LS	M Ma	S1 : Repair slope instability.	39.034107 ° -121.825152 °	39.034107 ° -121.825152 °	2
DWR ID: DWR_RD1660_01_s_2012_2										
11	2.44	2.44	Earthen Levee	Slope Stability	LS	M Ma	S1 : Repair slope instability.	39.033858 ° -121.824985 °	39.033858 ° -121.824985 °	4

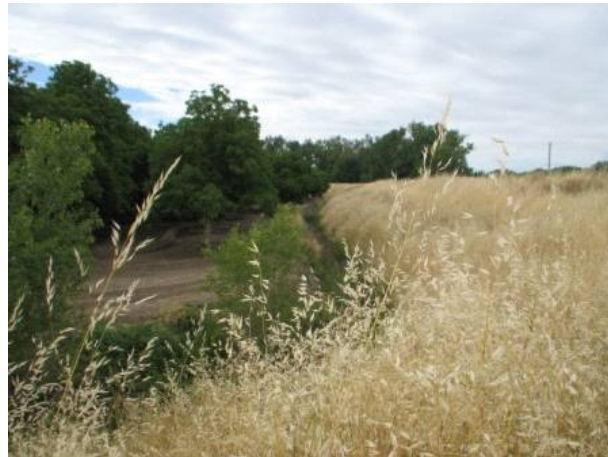
Levee Mile Report Line	9
Start Levee Mile	2.04
End Levee Mile	2.38
Location	Land Side
Category	Earthen Levee
Item	Encroachments

View of the large ditch along the landside toe.

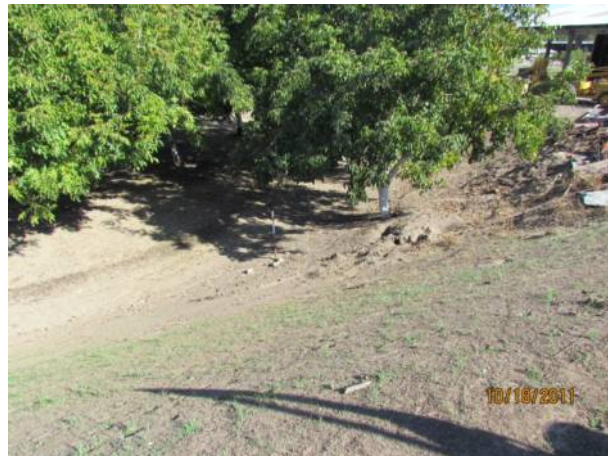
Levee Mile Report Line	12
Start Levee Mile	2.62
End Levee Mile	2.62
Location	Land Side
Category	Earthen Levee
Item	Animal Control

DWR ID: DWR_RD1660_01_s_2012_4										
12	2.62	2.62	Earthen Levee	Animal Control	LS	A/W Ma	A3 : No rodents visible, but rodent burrows visible; need to backfill and compact or grout burrows.	39.031520 ° -121.823420 °	39.031520 ° -121.823420 °	10 Y
DWR ID: DWR_RD1660_01_s_2012_10										
13	2.63	2.63	Earthen Levee	Encroachments	LS	M Ma	EQ : Equipment	39.031405 ° -121.823403 °	39.031405 ° -121.823403 °	3 Y
DWR ID: DWR_RD1660_01_s_2012_3										
14	2.68	2.71	Earthen Levee	Slope Stability	LS	M Ma	S1 : Repair slope instability.	39.030891 ° -121.822956 °	39.030436 ° -121.822617 °	5
DWR ID: DWR_RD1660_01_s_2012_5

View of rodent holes along the L/S slope.

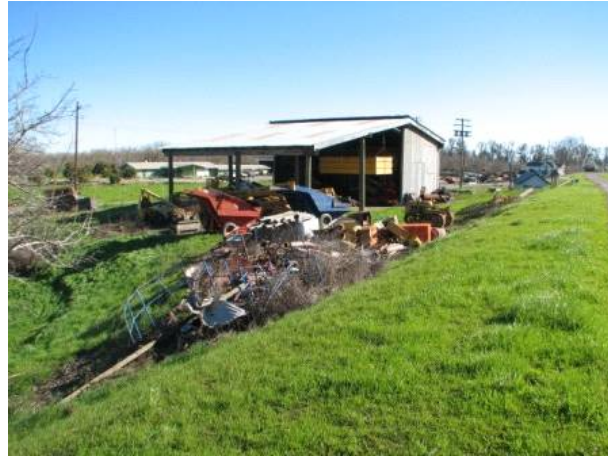
Levee Mile Report Line	13
Start Levee Mile	2.63
End Levee Mile	2.63
Location	Land Side
Category	Earthen Levee
Item	Encroachments

View of equipment along the slope.

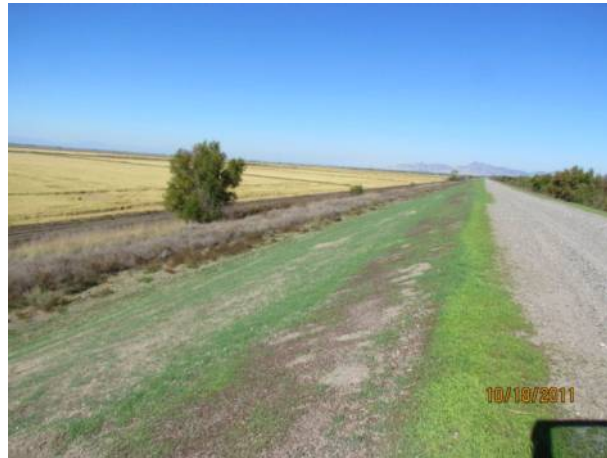
Levee Mile Report Line	4
Start Levee Mile	0.93
End Levee Mile	0.97
Location	Land Side
Category	Earthen Levee
Item	Animal Control

View of rodent holes along the L/S slope.

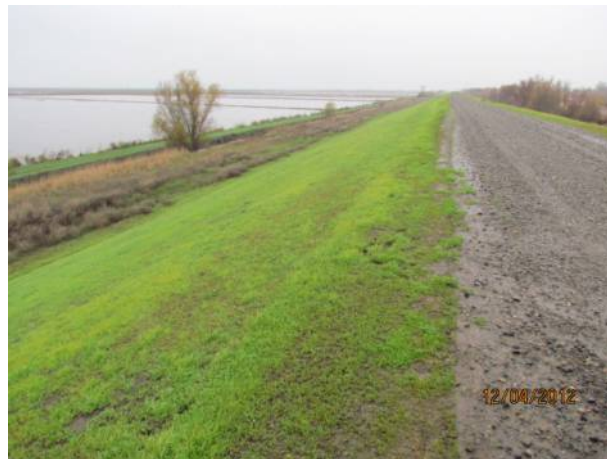
Levee Mile Report Line	4
Start Levee Mile	0.93
End Levee Mile	0.97
Location	Land Side
Category	Earthen Levee
Item	Animal Control

View of the repaired rodent holes on the landside slope.

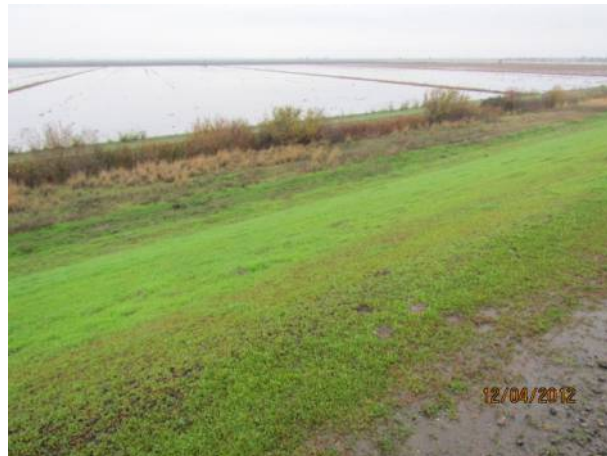
Levee Mile Report Line	5
Start Levee Mile	1.55
End Levee Mile	1.55
Location	Water Side
Category	Earthen Levee
Item	Animal Control

View of the repaired rodent holes on the landside slope of the levee.

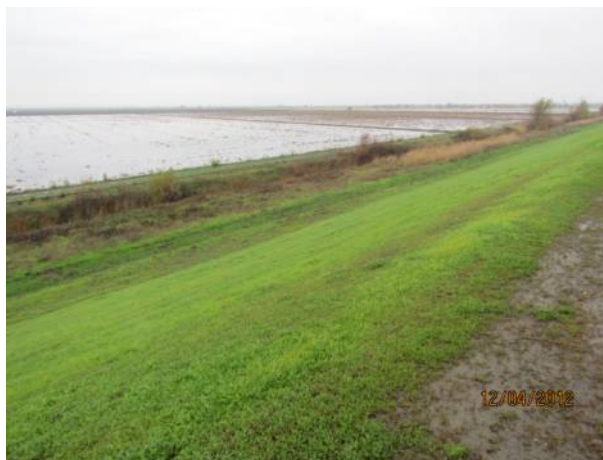
Levee Mile Report Line	6
Start Levee Mile	1.57
End Levee Mile	1.61
Location	Land Side
Category	Earthen Levee
Item	Animal Control

View of the repaired rodent holes on the landside slope of the levee.

DWR ID: DWR_RD1660_02_s_2012_7										
6	1.57	1.61	Earthen Levee	Animal Control	LS A/W Ma	A1 : Exterminate rodents and backfill and compact or grout burrows.	39.054595 ° -121.752460 °	39.055170 ° -121.752698 °	4 Y	
DWR ID: DWR_RD1660_02_s_2012_4										
7	5.07	5.07	Earthen Levee	Animal Control	WSA/W Ma	A3 : No rodents visible, but rodent burrows visible; need to backfill and compact or grout burrows.	39.102052 ° -121.774477 °	39.102052 ° -121.774477 °	6 Y	
DWR ID: DWR_RD1660_02_s_2012_6										
8	5.81	5.81	Earthen Levee	Vegetation	LS Ma	A V1 : Control annual grass and weeds on the levee slopes and easements.	39.109310 ° -121.784250 °	39.109310 ° -121.784250 °	5 Y	
DWR ID: DWR_RD1660_02_f_2012_5

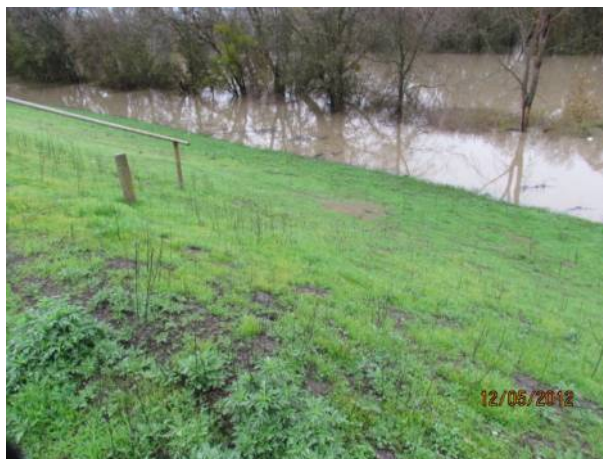
Levee Mile Report Line	7
Start Levee Mile	5.07
End Levee Mile	5.07
Location	Water Side
Category	Earthen Levee
Item	Animal Control

View of the repaired rodent hole on the waterside slope.

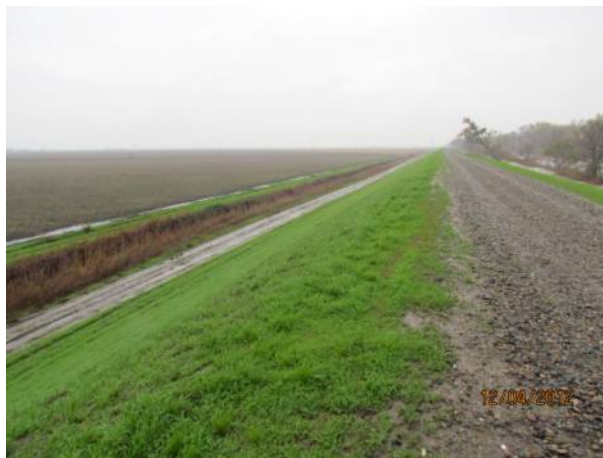
Levee Mile Report Line	8
Start Levee Mile	5.81
End Levee Mile	5.81
Location	Land Side
Category	Earthen Levee
Item	Vegetation

View of the vegetation start to grow on both levees.
